Manhole Inspection Summary

Manhole # S39C2_031MH

Insp Date: **12/10/07 9:40 AM**

Location Address: **4204 5th St**

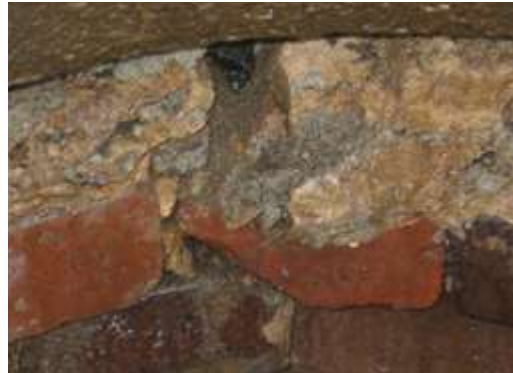
Defect 1

Condition: ☐ Sound ☒ **Cracked** ☐ Root Intrusion ☒ **Loose Brick** ☒ **Deteriorated**

Chimney crack & missing brick

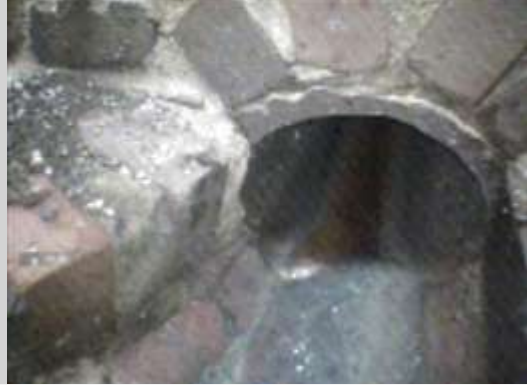
12 O'Clock Outflow

8 in. Circular Gravity Sewer
Pipe Out @ 12 O'Clock

Pipe Height: **8.4** (in.) Rod and Bar (Angled)
Pipe Material: **Clay** ☐ Pipe Lined
Invert Depth: **9.20** (ft.) Flow Characteristics: **Fast**
Deposits: ☐ None ☐ Mud ☒ **Sludge** ☐ Debris ☐ Grease
Silt Depth: **1** (in.) Deposits Extent: **Light**
Infiltration: **None** Pipe Seal Cond: **Sound**

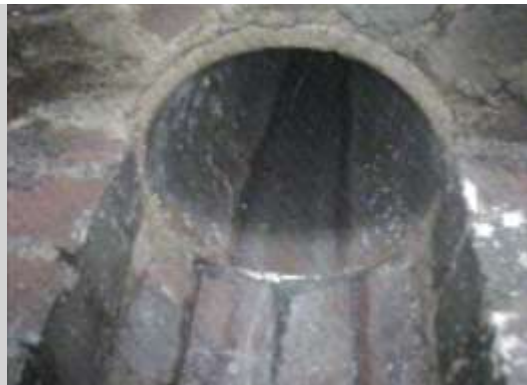
6 O'Clock Inflow

Comments **Influent pipe @ 6 O'Clock from Dead End feature not available in GIS.**

8 in. Circular Service Sewer
Pipe In @ 6 O'Clock

Pipe Height: **7.2** (in.) Rod and Bar (Angled)
Pipe Material: **Clay** ☐ Pipe Lined
Invert Depth: **8.56** (ft.) Flow Characteristics: **Fast**
Deposits: ☐ None ☐ Mud ☒ **Sludge** ☐ Debris ☐ Grease
Silt Depth: **1** (in.) Deposits Extent: **Light**
Infiltration: **None** Pipe Seal Cond: **Sound**

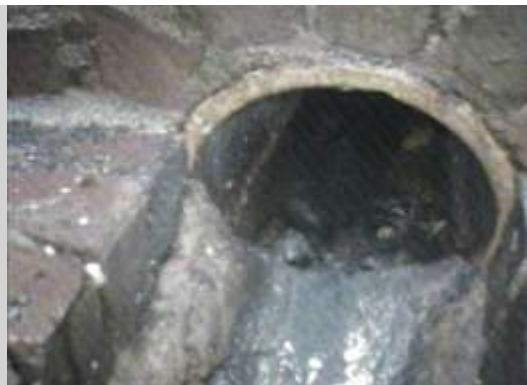
10 O'Clock Inflow

Deposits: ☐ None ☐ Mud ☒ **Sludge** ☐ Debris ☐ Grease

Silt Depth: **1** (in.) Deposits Extent: **Light**
